Asbestos Refurbishment Report

6 Eddeys Lane
Bordon
GU35 8HU

Octopus Energy

Reference: C-27537

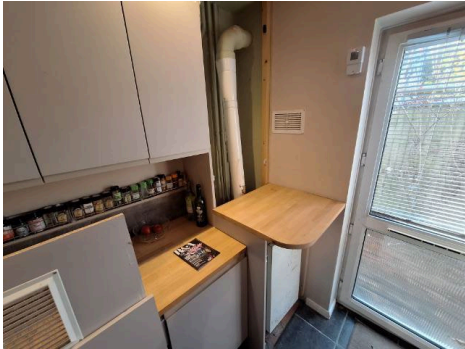
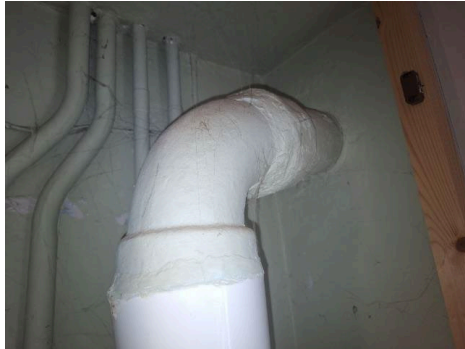
Building:	6 Eddeys Lane	Floor	Ground Floor		
Location ID	001	Location	Boiler cupboard		
Sample Number	S001	Extent	1 m ²		
Item / Position	Flue pipe	Material	Cement Product		
Product Type	Asbestos reinforced composites etc.	Scores	1		
Condition	Low Damage		1		
Surface Treatment	Sealed		1		
Asbestos Type	Chrysotile		1		
Material Assessment	Very Low		4		
Substrate	Bolted to timber	Accessibility	Medium		
Main Photo		Close Up Photo

Recommendation	Remove - NON-Licensed Material Removal by an asbestos contractor. This material is not licensed however may still be notifiable to the HSE prior to removal works taking place. All works must conform to the Control of Asbestos Regulations 2012.				
Comments	Plasterboard ceiling with smooth painted finish, solid plastered walls, concrete floor with vinyl floortiles. Bolted to timber

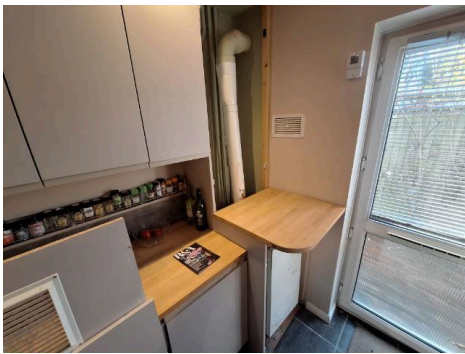
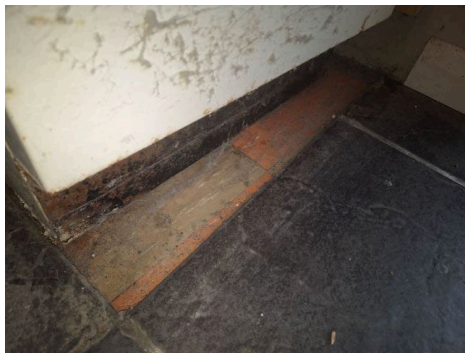
Building:	6 Eddeys Lane	Floor	Ground Floor		
Location ID	001	Location	Boiler cupboard		
Sample Number	S002	Extent	1 m ²		
Item / Position	Floortiles and bitumen adhesive	Material	Floor tiles & Bitumen		
Product Type	Asbestos reinforced composites etc.	Scores	1		
Condition	Good Condition		0		
Surface Treatment	Self Sealed		0		
Asbestos Type	Chrysotile		1		
Material Assessment	Very Low		2		
Substrate	Bonded to concrete	Accessibility	Medium		
Main Photo		Close Up Photo

Recommendation	Remove - NON-Licensed Material Removal by an asbestos contractor. This material is not licensed however may still be notifiable to the HSE prior to removal works taking place. All works must conform to the Control of Asbestos Regulations 2012.				
Comments	Plasterboard ceiling with smooth painted finish, solid plastered walls, concrete floor with vinyl floortiles. Bonded to concrete

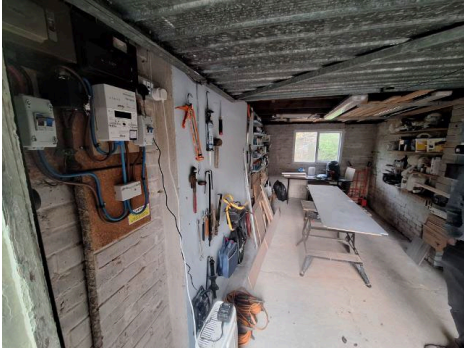
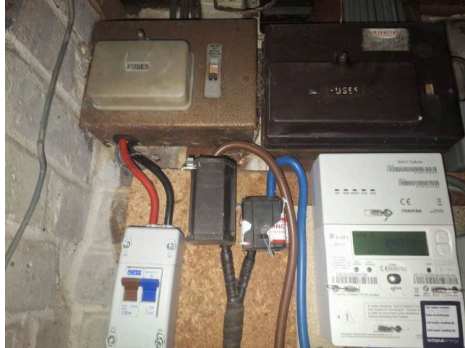
Building:	6 Eddeys Lane	Floor	Ground Floor		
Location ID	003	Location	Garage		
Sample Number	P	Extent	10< no		
Item / Position	Fuse guards	Material	Gaskets (rope/woven)		
Product Type	Asbestos insulating board, millboards, gaskets & ropes etc.	Scores	2		
Condition	Good Condition		0		
Surface Treatment	Partially Unsealed		2		
Asbestos Type	Presumed Chrysotile		1		
Material Assessment	Low		5		
Substrate	Unable to sample due to live supply.	Accessibility	Low		
Main Photo		Close Up Photo

Recommendation	Inaccessible Items / Strongly Presumed Inaccessible item. Isolation, access and sampling will be required prior to any works which may disturb the presumed item.				
Comments	Timber ceiling, brick walls, concrete floor. MMMF insulation within cavity. Old electrics. Unable to sample due to live supply.

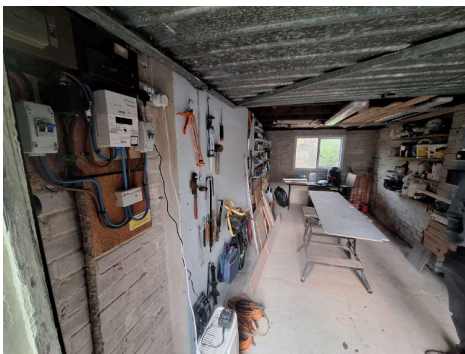
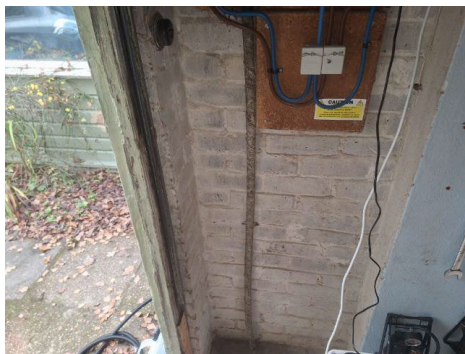
Building:	6 Eddeys Lane	Floor	Ground Floor		
Location ID	003	Location	Garage		
Sample Number	P	Extent	1 no		
Item / Position	Cable wrap	Material	Bituminous Product		
Product Type	Asbestos reinforced composites etc.	Scores	1		
Condition	Good Condition		0		
Surface Treatment	Self Sealed		0		
Asbestos Type	Presumed Chrysotile		1		
Material Assessment	Very Low		2		
Substrate	Unable to sample due to live supply.	Accessibility	Low		
Main Photo		Close Up Photo

Recommendation	Inaccessible Items / Strongly Presumed Inaccessible item. Isolation, access and sampling will be required prior to any works which may disturb the presumed item.				
Comments	Timber ceiling, brick walls, concrete floor. MMMF insulation within cavity. Old electrics. Unable to sample due to live supply.

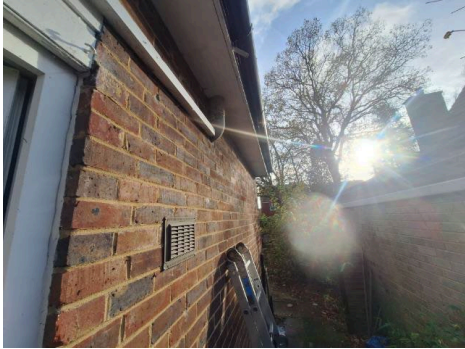
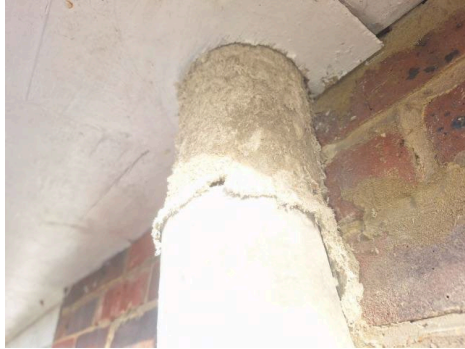
Building:	6 Eddeys Lane	Floor	External		
Location ID	003	Location	Externals		
Sample Number	S003	Extent	0.5 lin m		
Item / Position	Pipe lagging	Material	Insulation		
Product Type	Thermal insulation, sprayed asbestos, loose asbestos etc.	Scores	3		
Condition	High Damage		3		
Surface Treatment	Unsealed		3		
Asbestos Type	Chrysotile		1		
Material Assessment	High		10		
Substrate	Wrapped around pipe.	Accessibility	Medium		
Main Photo		Close Up Photo

Recommendation	Remove - Licensed Material Removal by a licensed asbestos contractor. This material is licensed therefore is subject to a 14 notification to the HSE prior to removal works taking place. All works must conform to the Control of Asbestos Regulations 2012.				
Comments	Pitched tiled roof, plastic rain water goods, timber fascia and soffits, bare brick walls. Cement down pipes Cement flue pipe. Timber wall cladding. Roofing felt. Cement undercloaking. Wrapped around pipe.
