**Beech Hill Stores
Eddeys Lane
Headley Down
Bordon**

**Quantitative Ground Contamination
Risk Assessment Report**

Project Reference: P15204

Report Reference: R14868

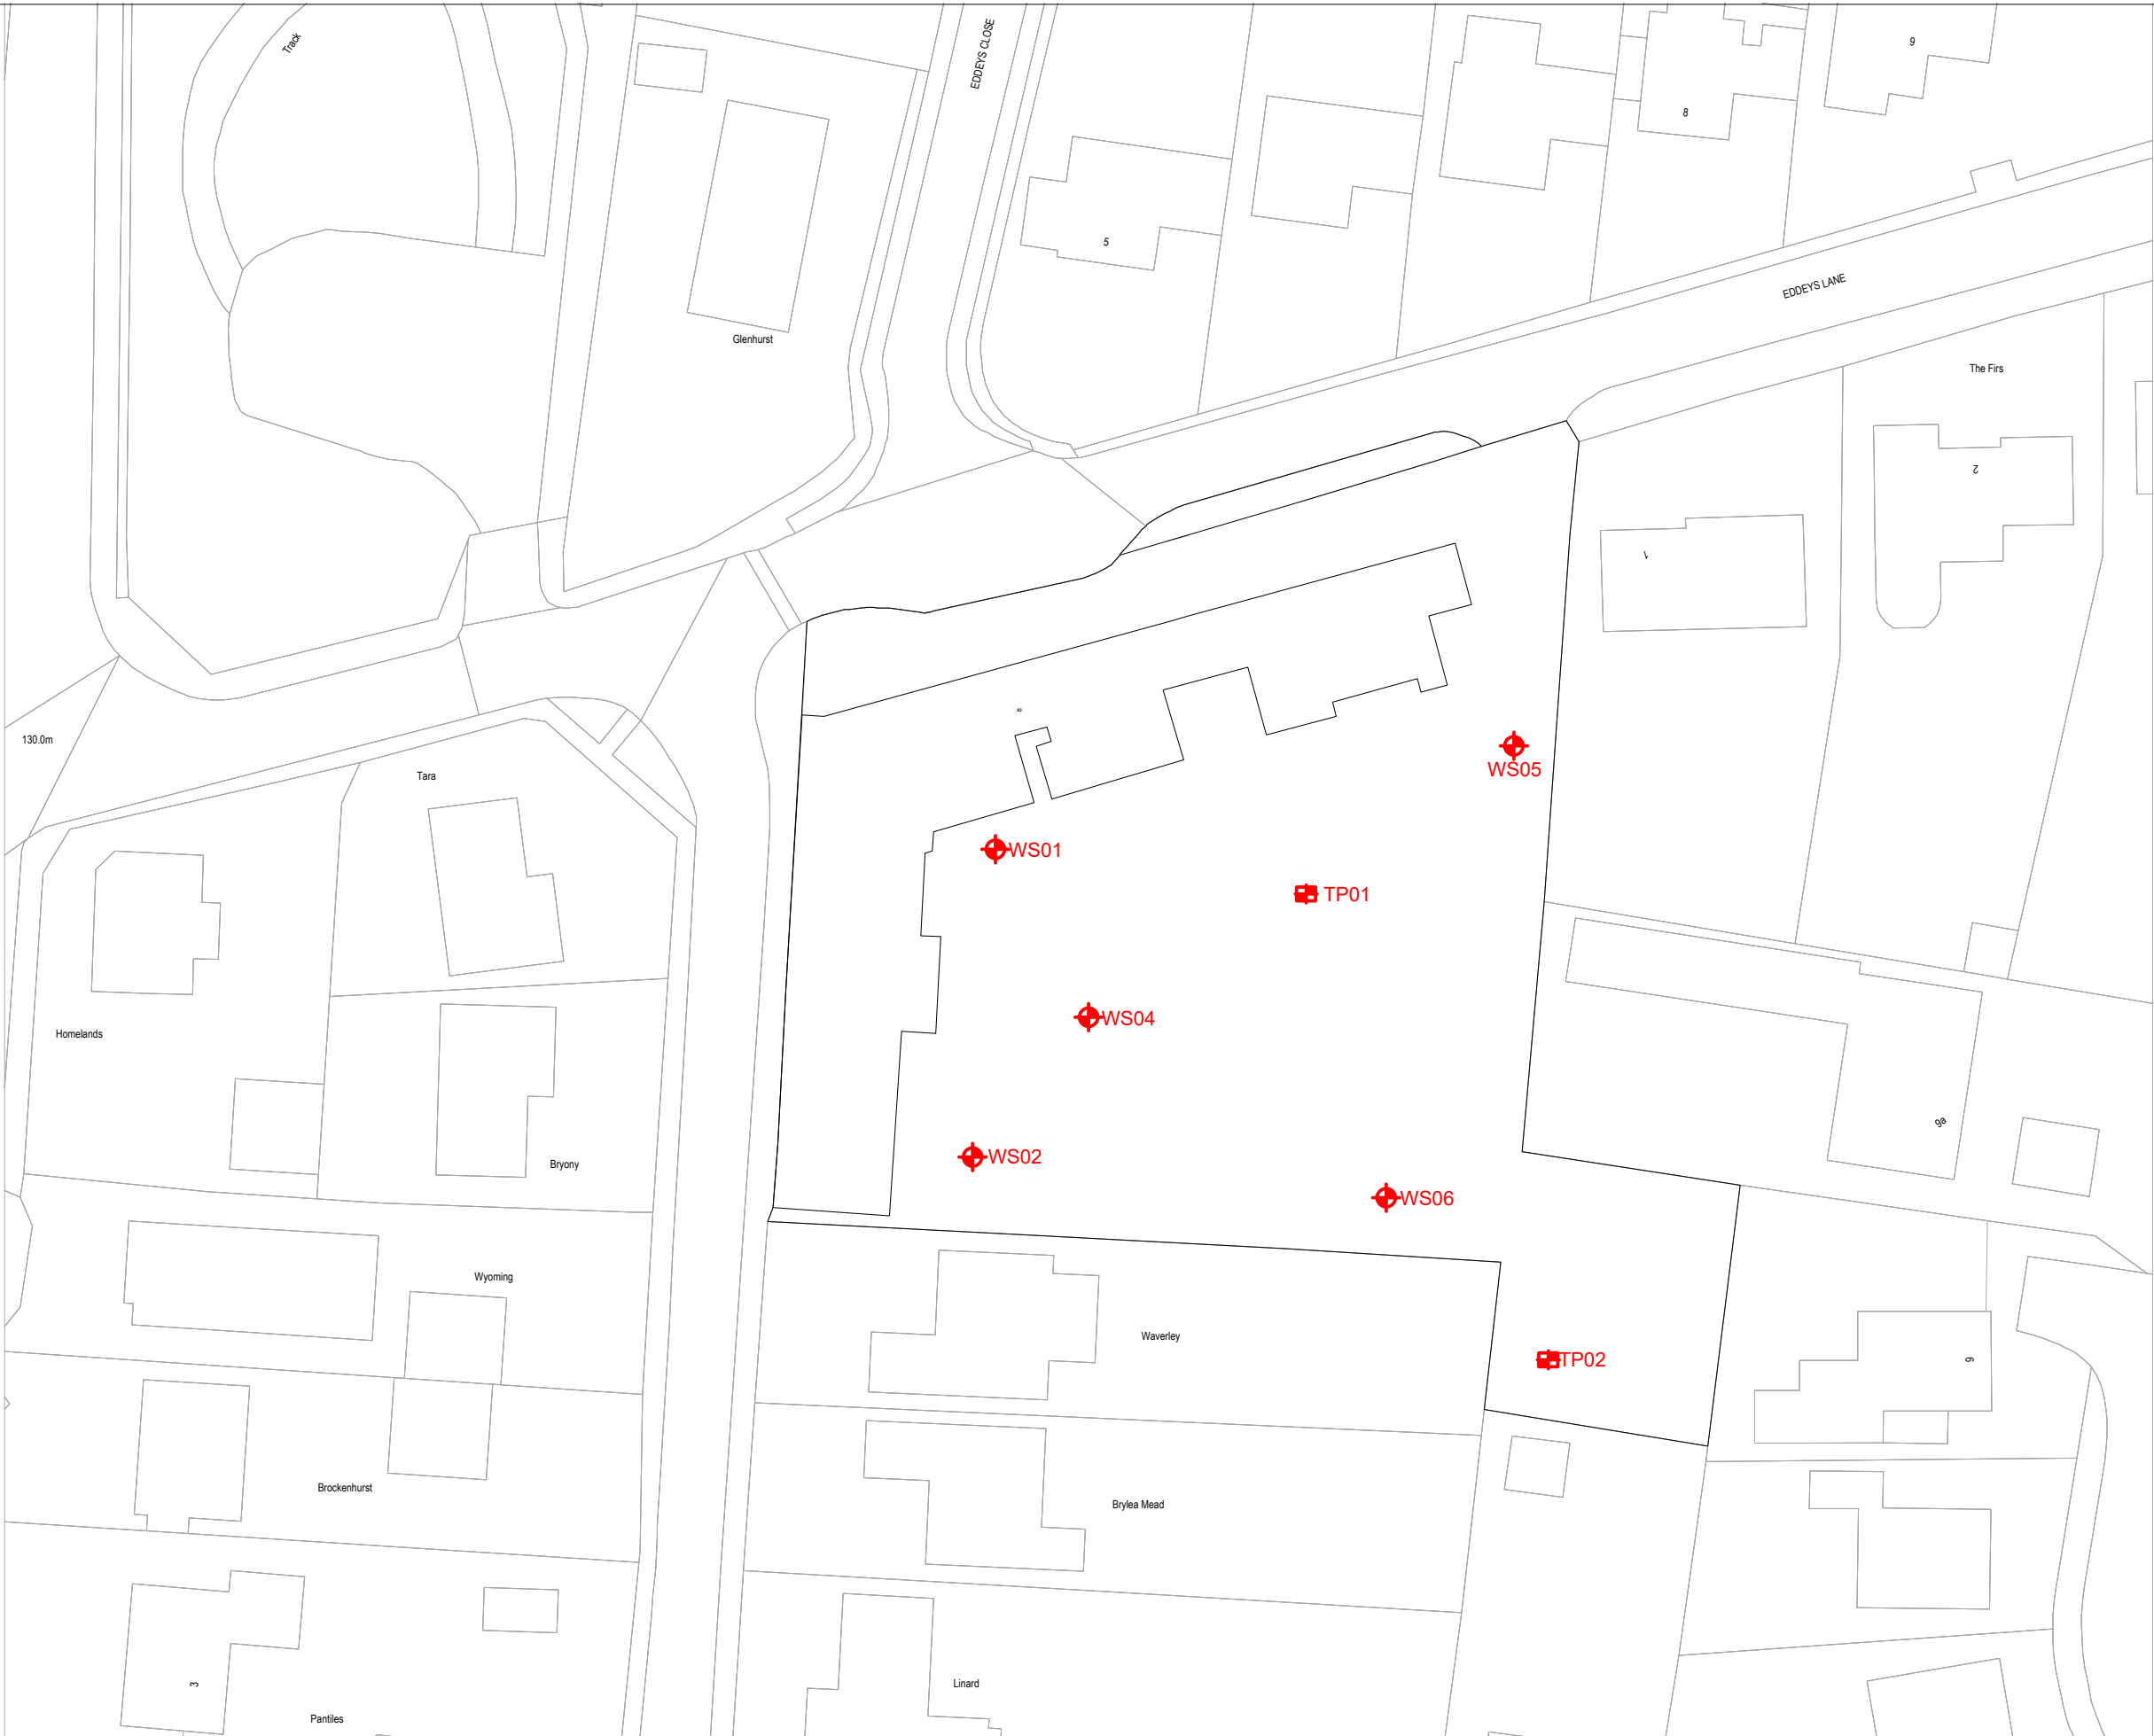
Figure 2 Site Plan

The ground investigation comprised the excavation of a series of dynamic sampler boreholes and hand dug pits. Gas and groundwater monitoring standpipes were installed in selected exploratory holes and monitored on subsequent site visits. The fieldwork was carried out on 10th June 2021. The exploratory hole locations are shown on Figure 2.

The site comprises an irregular shaped plot of land located to the south of Eddeys Lane and to the east of Beech Hill, Headley Down, Bordon and is centred on the approximate Ordnance Survey national grid reference 483780 136470. A site location plan and site plan are presented as Figure 1 and Figure 2, respectively.

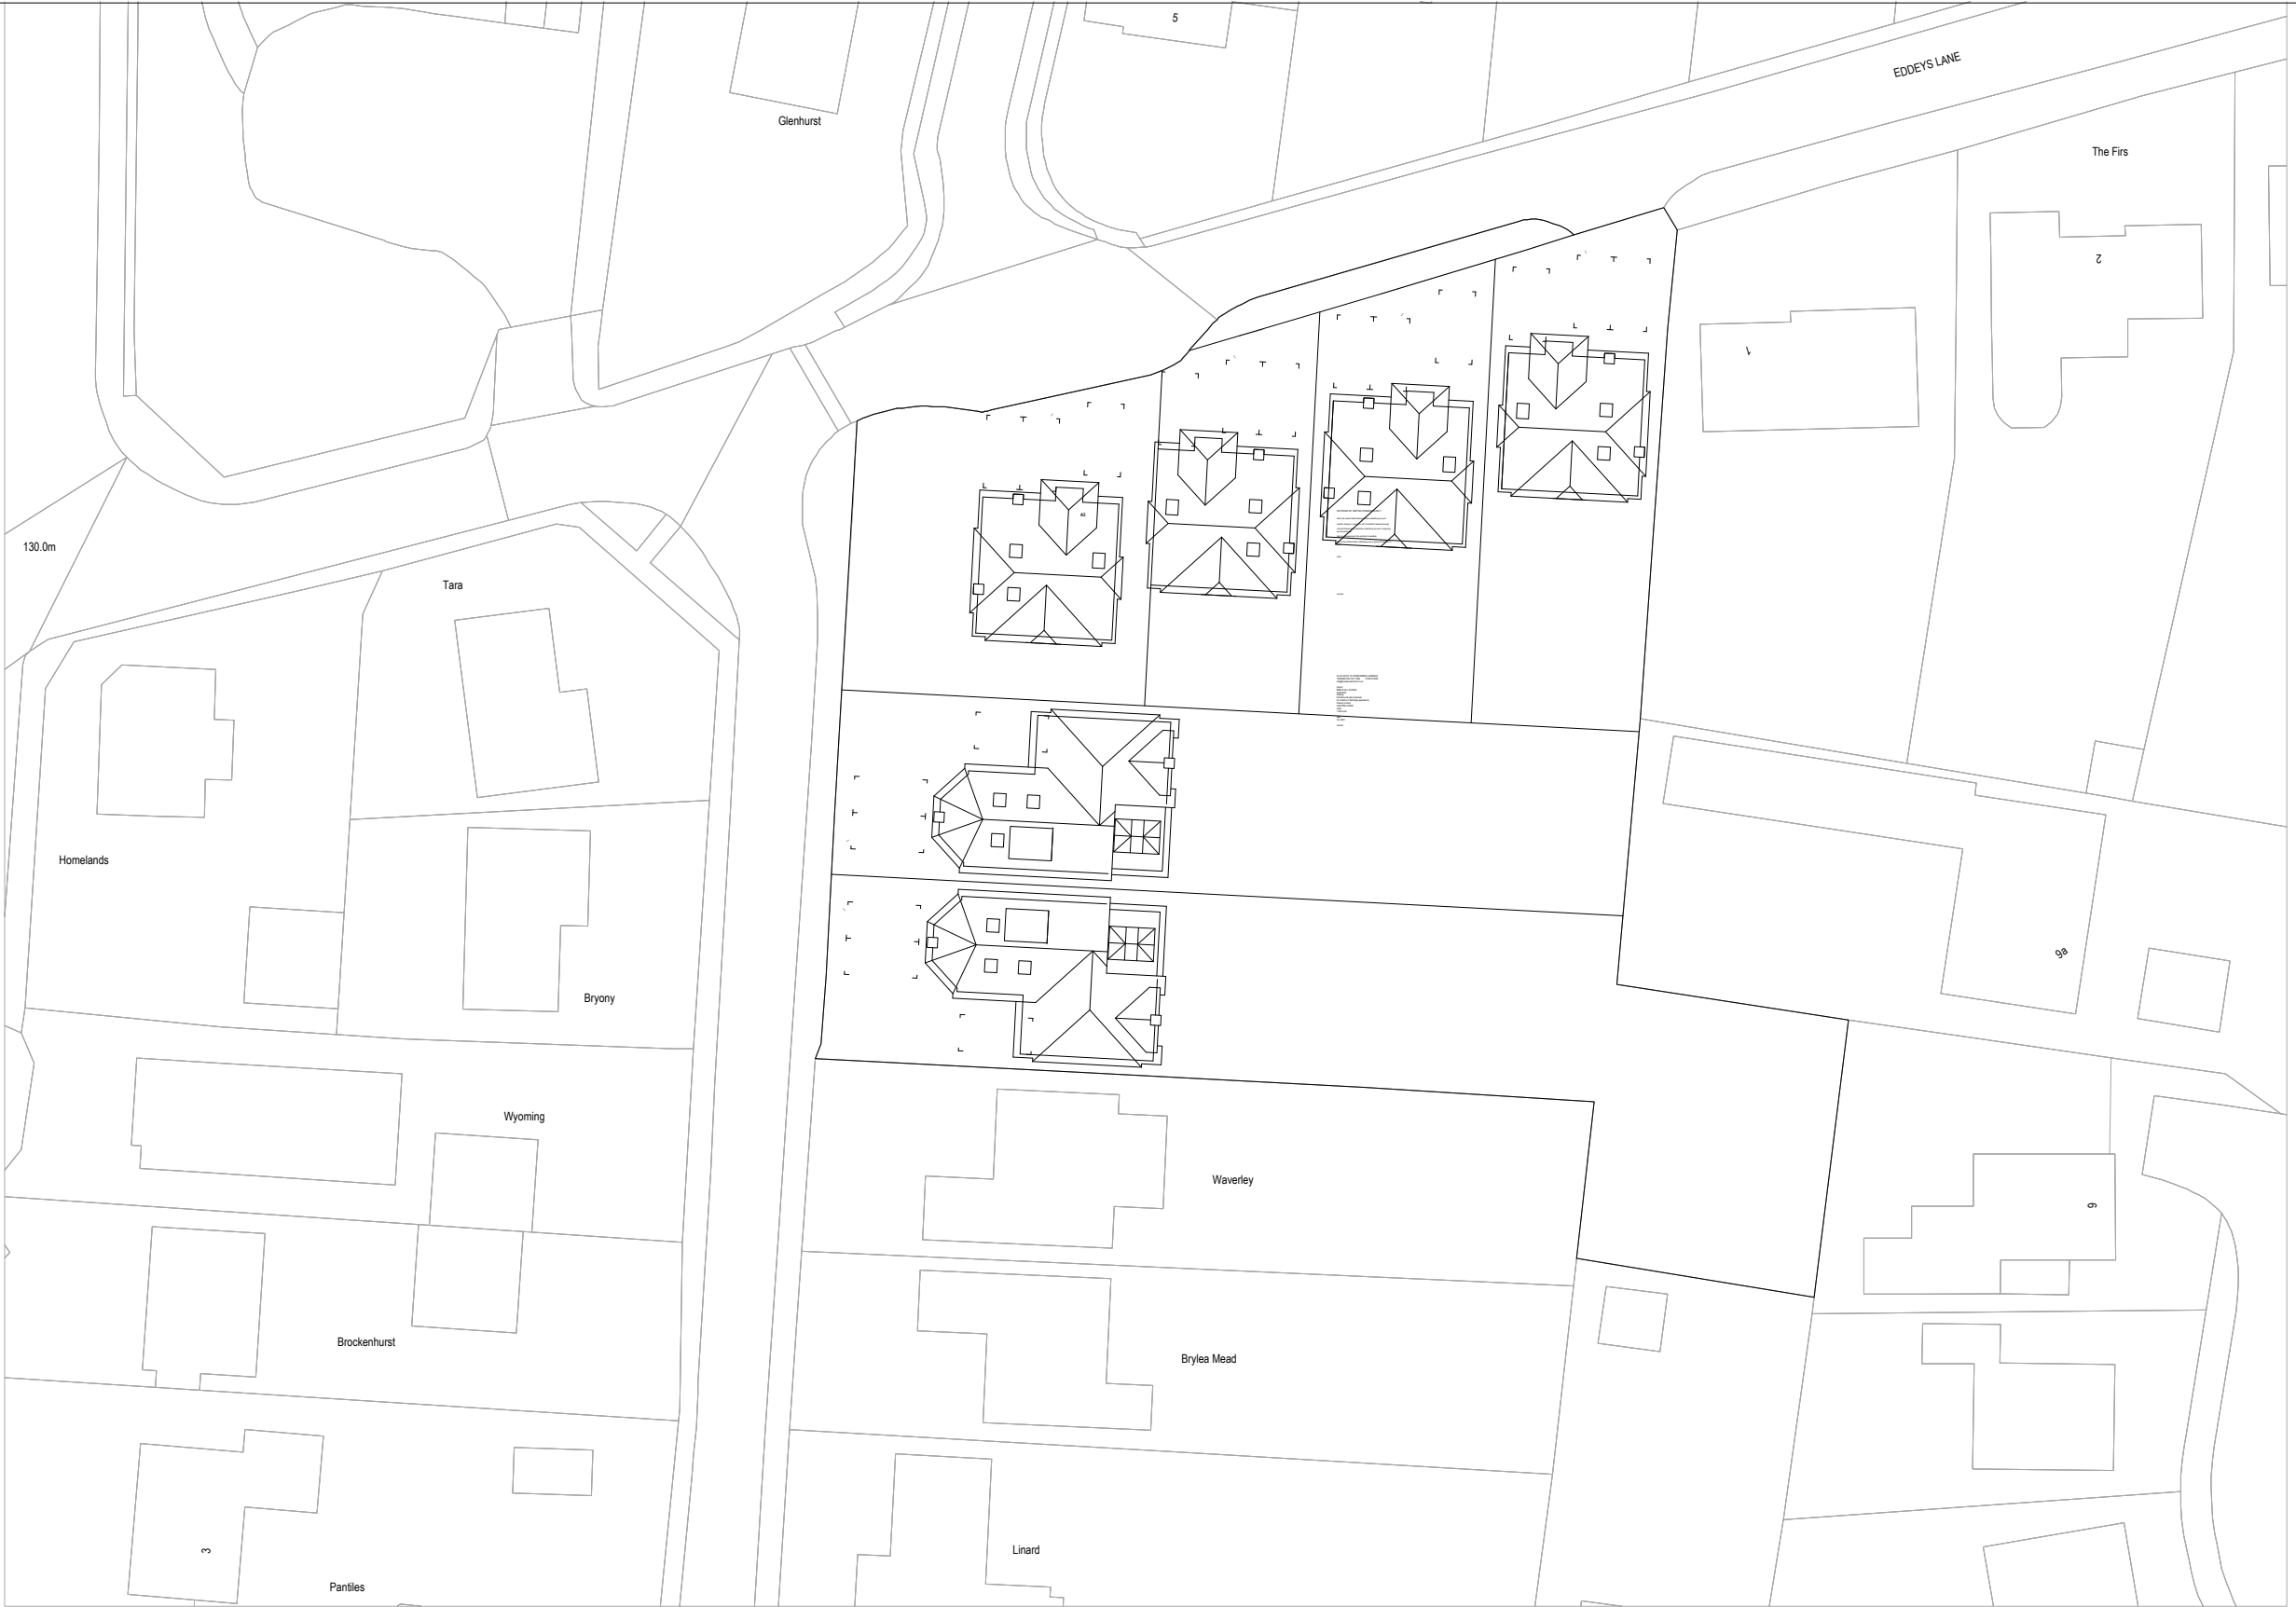
Proposed Development Layout

It is proposed to develop Beech Hill Stores located at Eddeys Lane, Headley Down, Bordon. The development proposals are understood to comprise the demolition of the existing buildings and the construction of six residential dwellings together with associated parking and landscaping. A copy of the proposed development layout is presented in Appendix A.
