**Beech Hill Stores
Eddeys Lane
Headley Down
Bordon**

Remediation Strategy

Project Reference: C15329

Report Reference: R14996

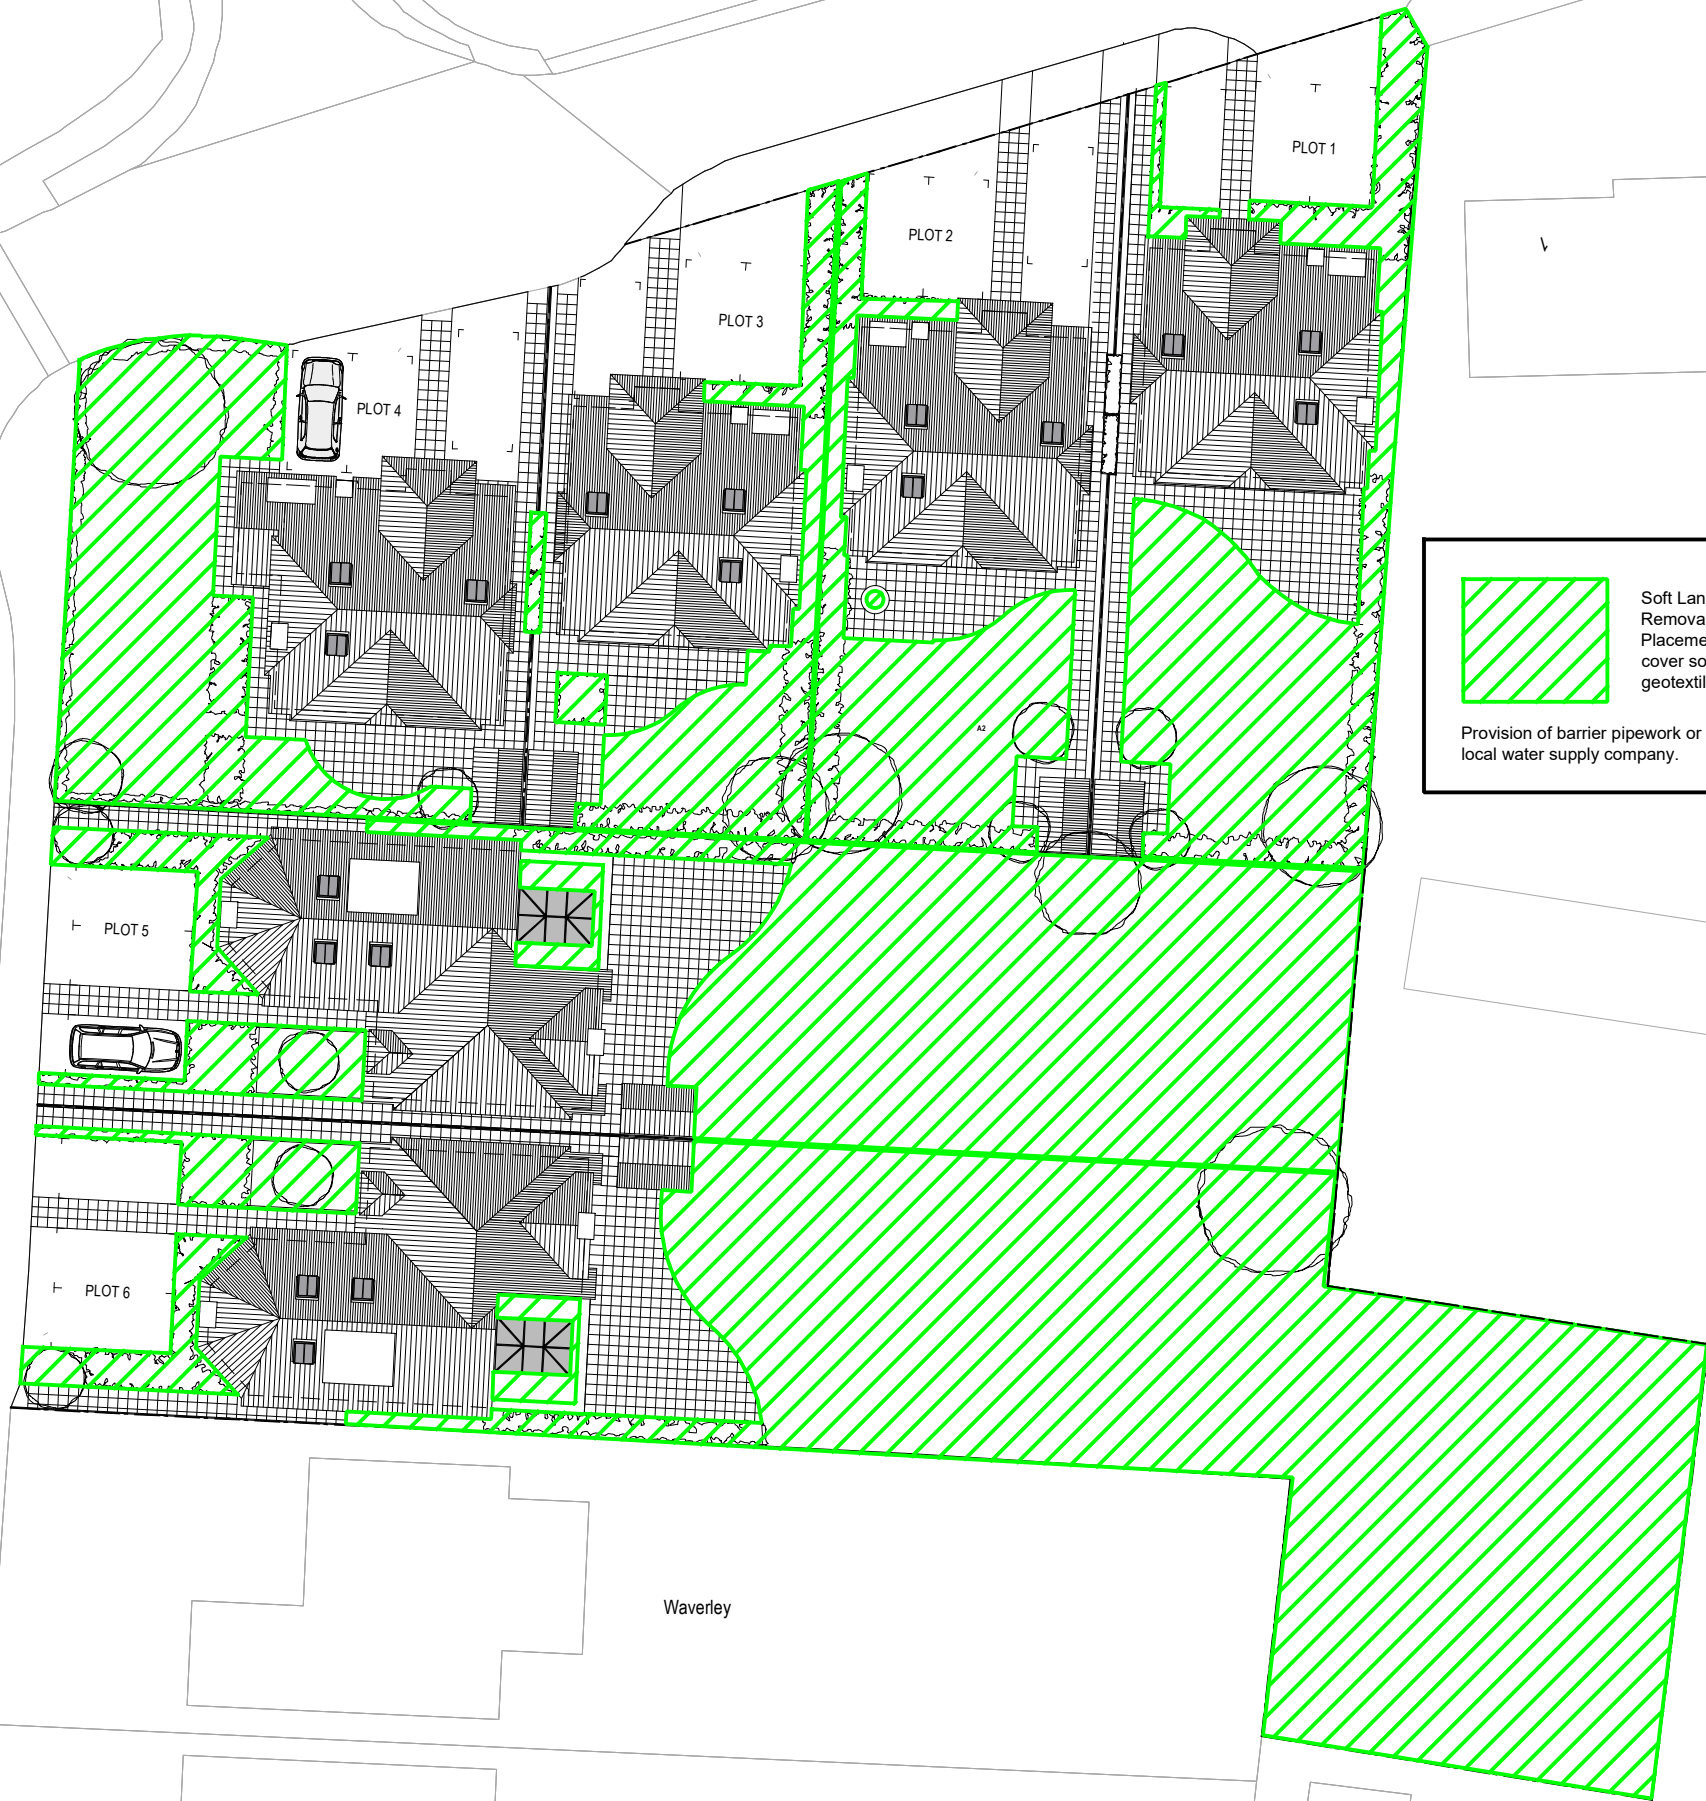
Figure 2 Remedial Works Plan

Soft Landscaped Areas:
Removal of all made ground soils **OR**
Placement of 600mm of verified "clean"
cover soils overlying a high visibility
geotextile marker.

Provision of barrier pipework or other pipework acceptable to
local water supply company.

The extents of the proposed remedial works are detailed on Figure 2.

For all areas where remediation works are required (reference Figure 2), the formation level will be inspected prior to placement of any cover soils to confirm that excavations are sufficiently deep to enable placement of the required thickness of cover soils or to confirm the removal of all made ground soils.
